EGG-TMI-8020
April 1988

ASSESSMENT OF TMI-2 PLENUM ASSEMBLY DAMAGE

EG&G Idaho, Inc.
Idaho Falls, Idaho 83415

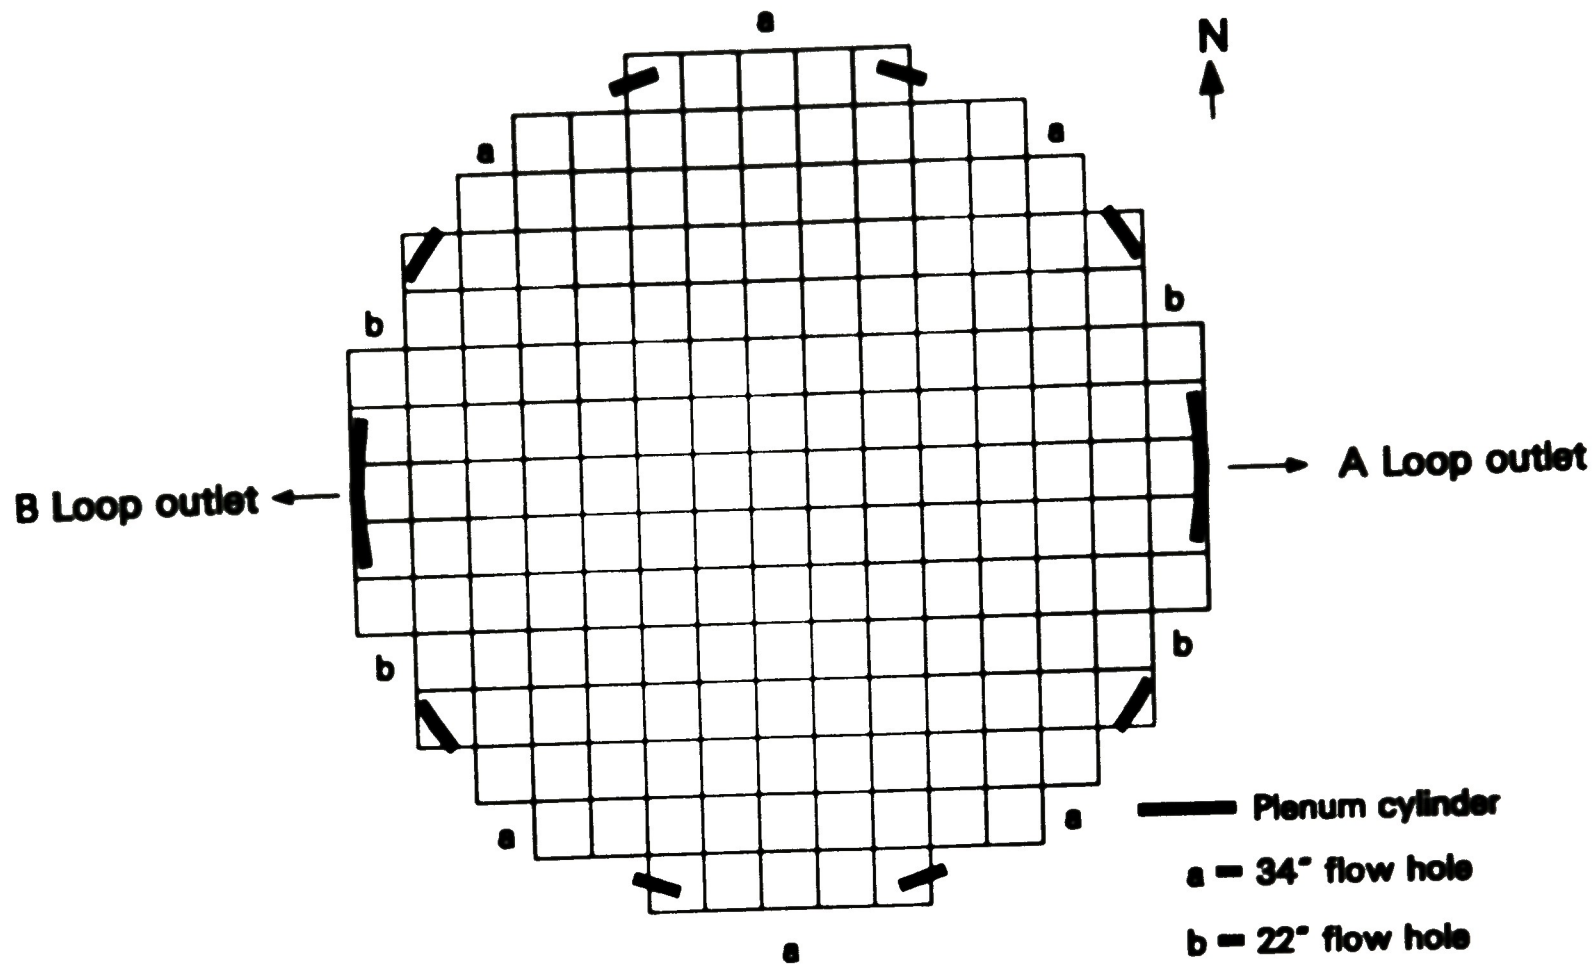
P656 PUI-288-05

Although these smaller holes provide shorter paths for the flow from the reactor core to the outlets (equivalent to a 14.7-inch hole at each nozzle), they are not expected to carry much of the flow as the larger holes would because of their size. The positions of the flow holes may have affected the damage pattern in the plenum assembly. This is discussed in Section 3 on the observed plenum assembly damage. The positions of these holes around the circumference of the plenum cylinder are shown in Figure 5.

Figure 5. Azimuthal locations of main flow holes in the plenum cylinder.

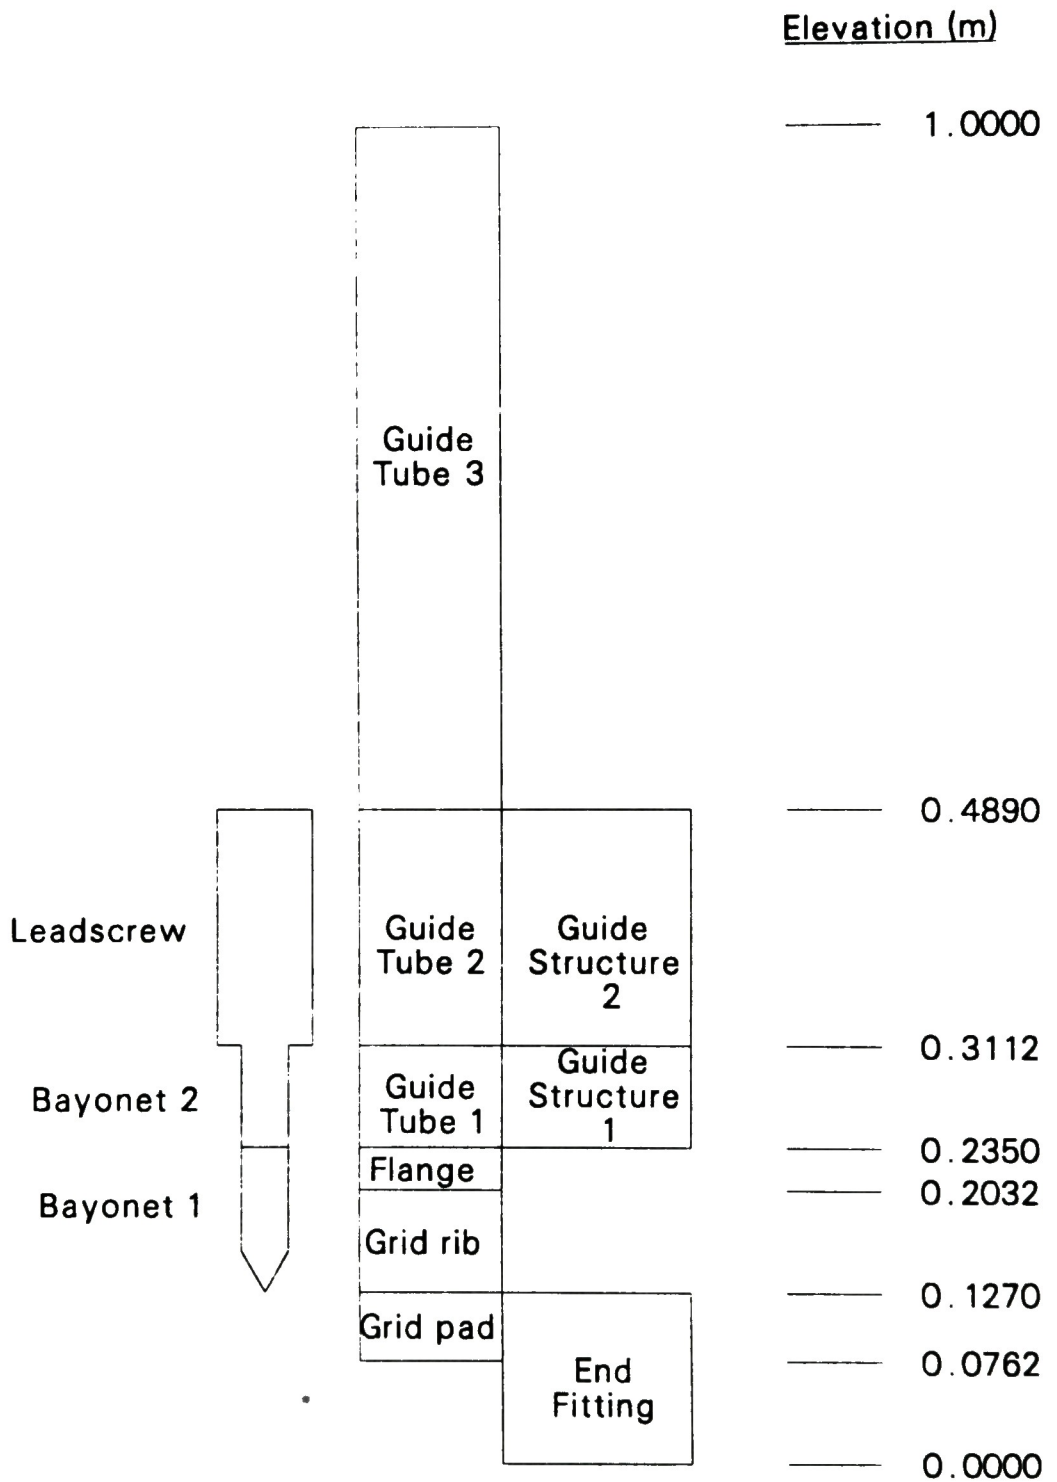
P556-WHT-288-05

The thermal calculation model of a unit cell of the plenum assembly is shown in Figure 27. The figure identifies the components modeled in the heat transfer calculations but does not represent the actual arrangement of the components, except for their relative elevations. All the structures are modeled up to the 0.489-m elevation, relative to the bottom of the upper end fittings of the fuel assemblies. These include the end fittings,

Figure 27. Model of a plenum assembly grid structure unit cell for thermal calculations.

Plenum assembly heating calculations are performed for three values of the effective gas emissivity--0.3, 0.5 and 0.7. The results are presented in Tables 4 through 6. Listed in the tables are the structures (as depicted in Figure 27), their temperatures and melted fractions for three times after the initiation of the pump transient (174 min 9 s). At the bottom of each table, the total amount of melted material in the plenum assembly and total energy transferred to the structures are also given. The total amounts are for the 61 equivalent damaged grid positions.

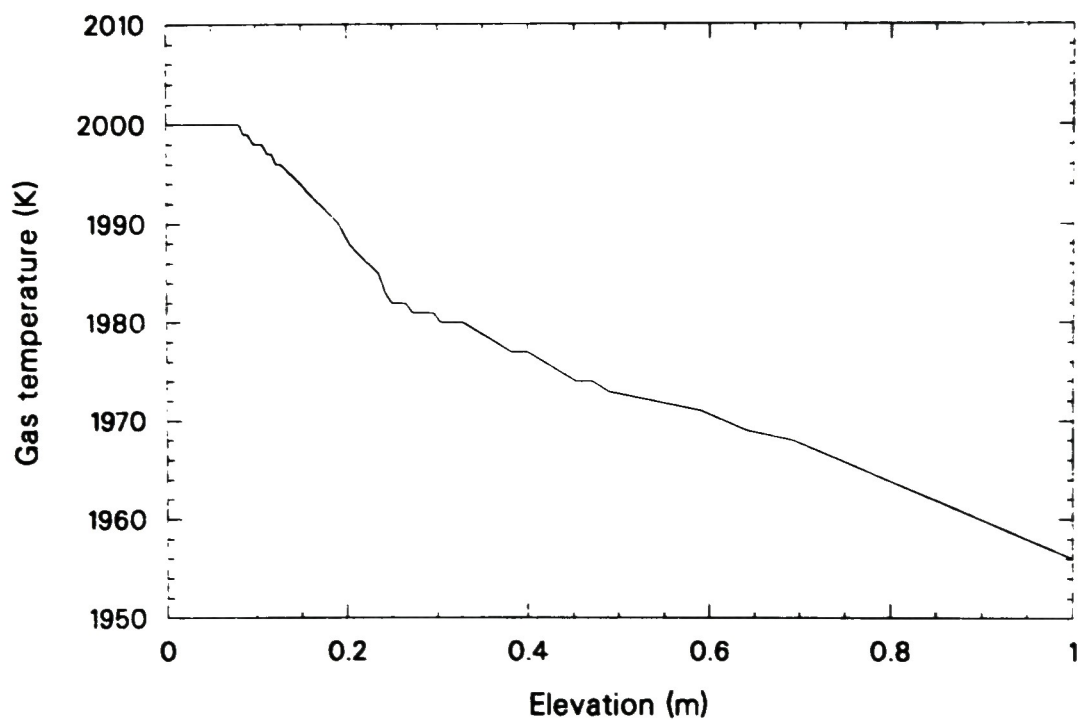
P556-WHT-288-18

Section 4.3 gives an energy transfer of 30 GJ to the fluids during the pump transient. The energy transfer from the hot gas to the plenum assembly structures, however, is less than 2 GJ, as shown in Tables 4 through 6. Therefore, the heat transfer to the plenum assembly was only a minor thermal perturbation. This can also be seen from the slow decrease in gas temperature as a function of elevation. The gas temperature at 100 s (as a function of elevation for the low emissivity case) is shown in Figure 28. (Gas temperature distributions at other times and emissivities are similar to the one shown.)

Figure 28. Calculated gas temperature distribution in the upper plenum during plenum assembly heating.
